INTERSTATE COMMERCE COMMISSION

REPORT OF THE DIRECTOR OF THE BUREAU OF SAFETY IN RE INVESTIGATION OF AN ACCIDENT WHICH OCCURRED ON THE NEW YORK, NEW HAVEN & HARTFORD RAILROAD NEAR EAST HARTFORD, CONN., ON FEBRUARY 2, 1931.

February 26, 1931.

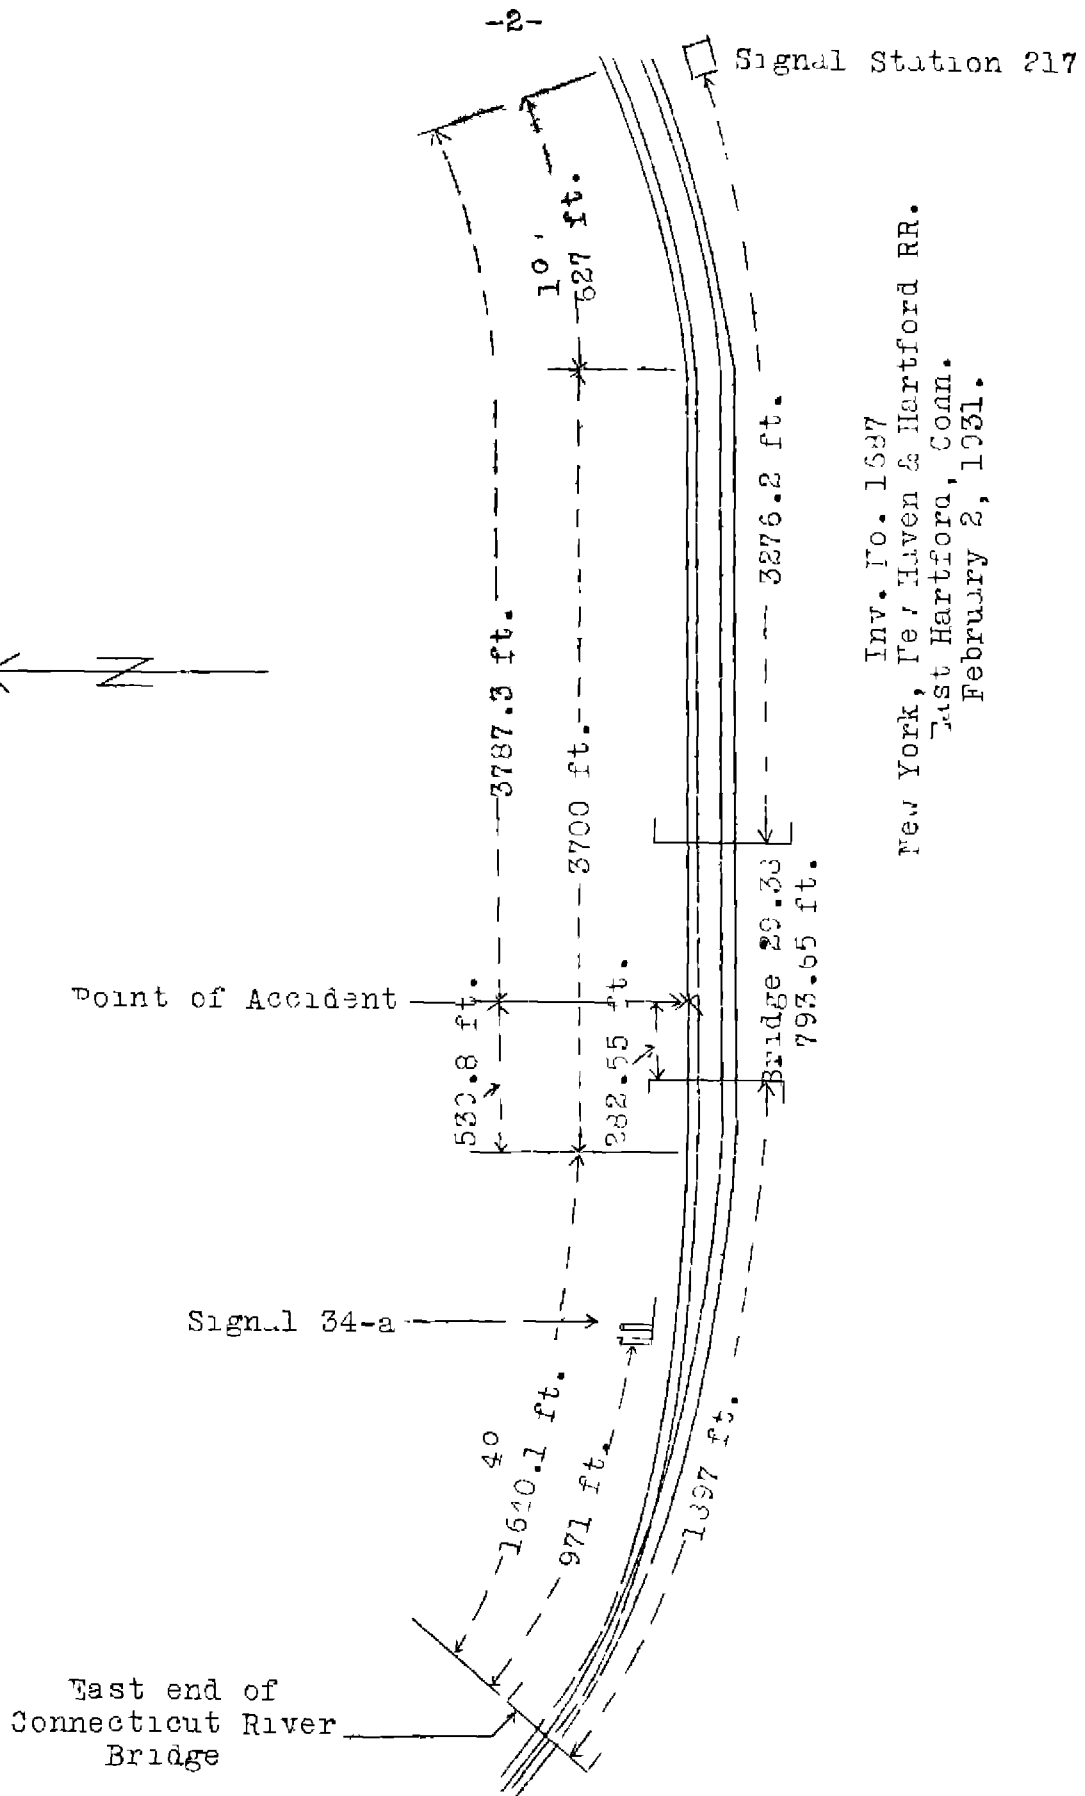
Inv. No. 1537
 New York, New Haven & Hartford RR.
 East Hartford, Conn.
 February 2, 1931.

This accident occurred on that part of the Hartford Division extending between Hartford and East Hartford, a distance of 2.61 miles, in the immediate vicinity of the point of accident this is a double-track line, within yard and interlocking limits. Signal station 217 is located at the west end of the west yard at East Hartford; bridge 29.38, 793.65 feet in length, is located 3,276.2 feet west of signal station 217 and the accident occurred on this bridge, on the westbound track, at a point 283.55 feet from the western end, or 3,787.3 feet west of signal station 217; the bridge is 21 feet high at the point of accident. Approaching the point of accident from the east, there is a 1° curve to the right 627 feet in length, and 3,700 feet of tangent track, followed by a 4° curve to the right 1,640.1 feet in length, the accident occurring on this tangent track at a point 539.8 feet from its western end. The grade is 0.55 per cent descending for westbound trains.

Bridge 29.93 over the Connecticut River is located 1,897 feet west of bridge 29.38 and the trackage over this bridge consists of a gauntlet track, westbound movements over the gauntlet track being governed by signal 34-a, controlled from an interlocking tower located west of the bridge, signal 34-a is located 971 feet east of the bridge.
